# INSPECTION REPORT

<b>PROJECT'S NAME :</b> SYS PRIMERBOND (Standard)	<b>CONTRACTOR :</b> CSH	<b>SHOP :</b> Siam Yamato Steel <b>DATE :</b> 29/1/2019
--	----------------------------	--

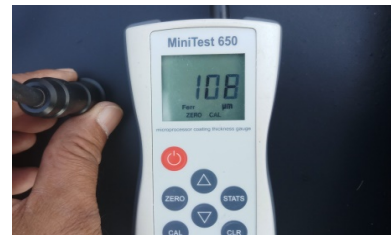
**ROUGH SKETCH OF MEASUREMENT POSITION**

SPEC D.F.T.            **80**    MICRONS  
CHECK D.F.T.        **93.3**   MICRONS
